NASA TN D-7703

FLIGHT EVALUATION OF ADVANCED
CONTROL SYSTEMS AND DISPLAYS
ON A GENERAL AVIATION AIRPLANE

*by Paul C. Loschke, Marvin R. Barber,
Einar K. Enevoldson, and Thomas C. McMurtry*

*Flight Research Center
Edwards, Calif. 93523*

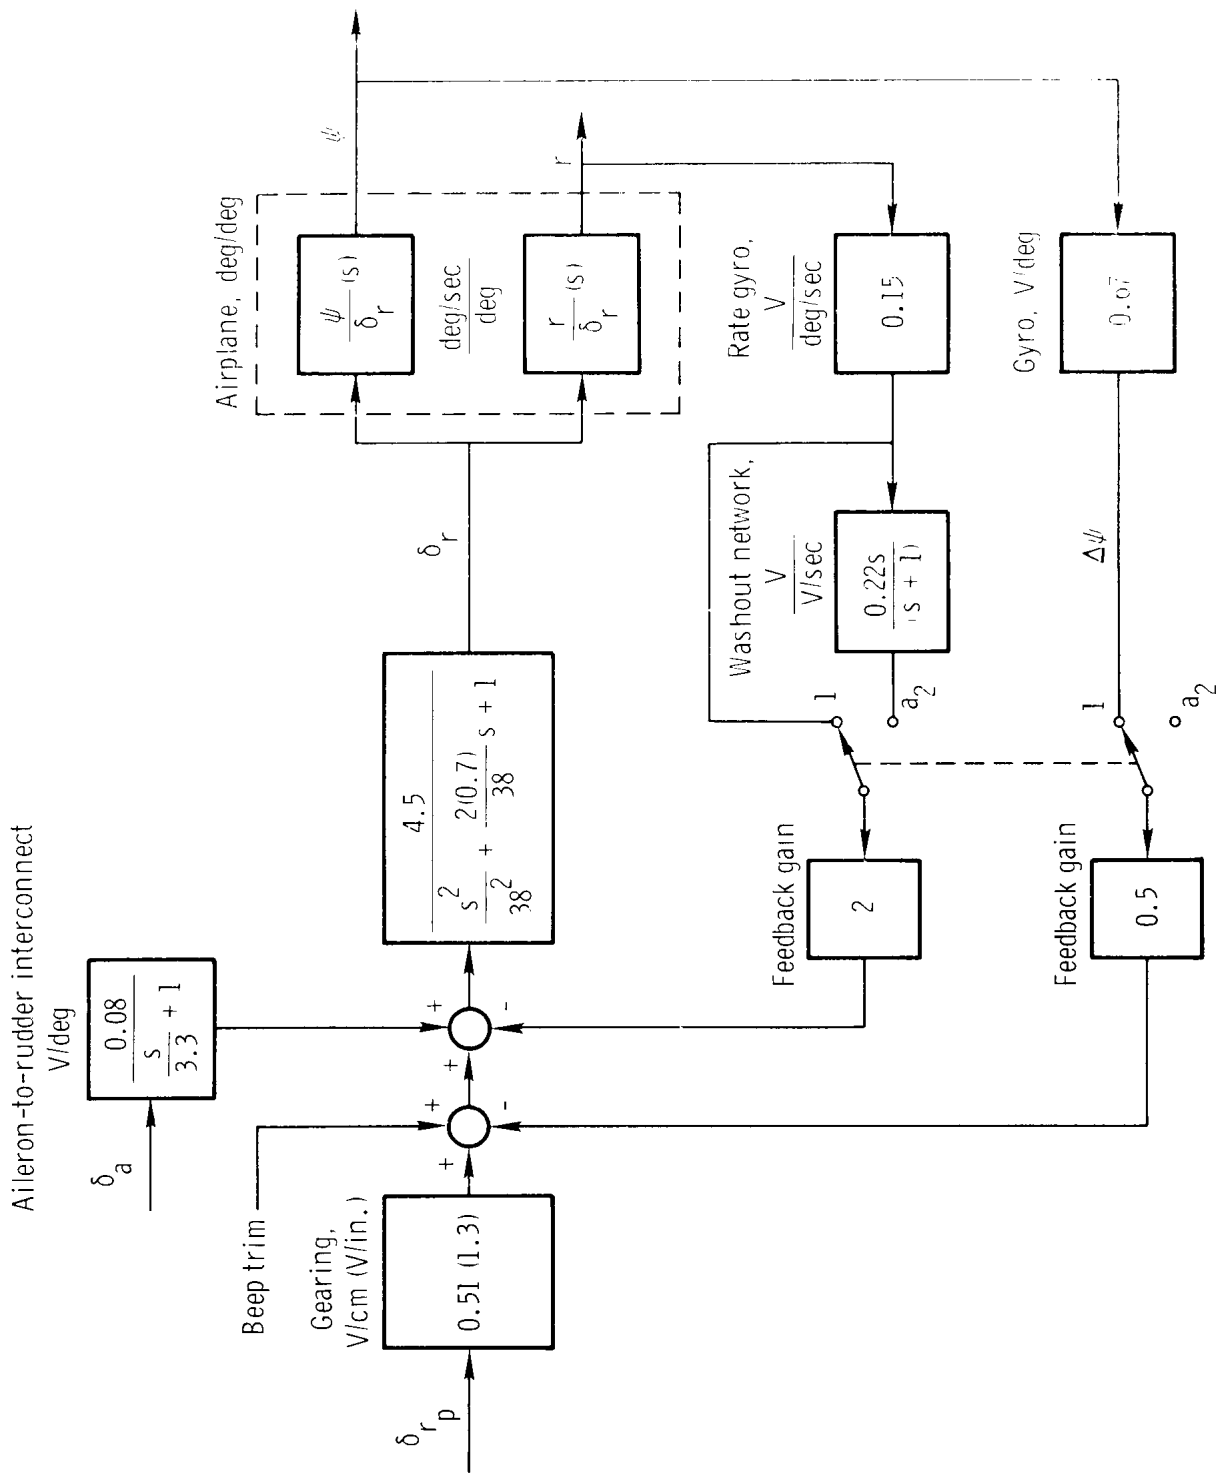
^aPosition 2 when $|\phi| \geq 3^\circ$ or beep trim on or both.

Figure 10. Yaw-heading-hold system.

Figure 10 shows a block diagram of the heading-hold mode mechanized in the yaw axis. The system was designed to maintain constant heading during level flight by mechanizing yaw rate and heading angle as feedback parameters to the rudder actuator. Yaw-rate feedback attenuated the Dutch-roll oscillation and increased the Dutch-roll damping to approximately 0.7. The heading-angle feedback loop opened when roll angle equaled or exceeded $\pm 3^\circ$ to permit turns. At the same time that the heading-angle loop opened, washed-out yaw rate was fed back to eliminate actuator responses during constant rate turns. An aileron-to-rudder interconnect was mechanized to eliminate high adverse aileron yaw as the pilot rolled into and out of the turn. The heading-hold loop also opened when the pilot activated the yaw beep trim. This allowed the pilot to trim sideslip with the wings level after a new heading was established. Moving the rudder pedals 0.64 centimeter (0.25 inch) or more also opened the heading loop. However, the pilots observed that they never needed to use the rudder pedals because the aileron-to-rudder interconnect provided coordination during turns.

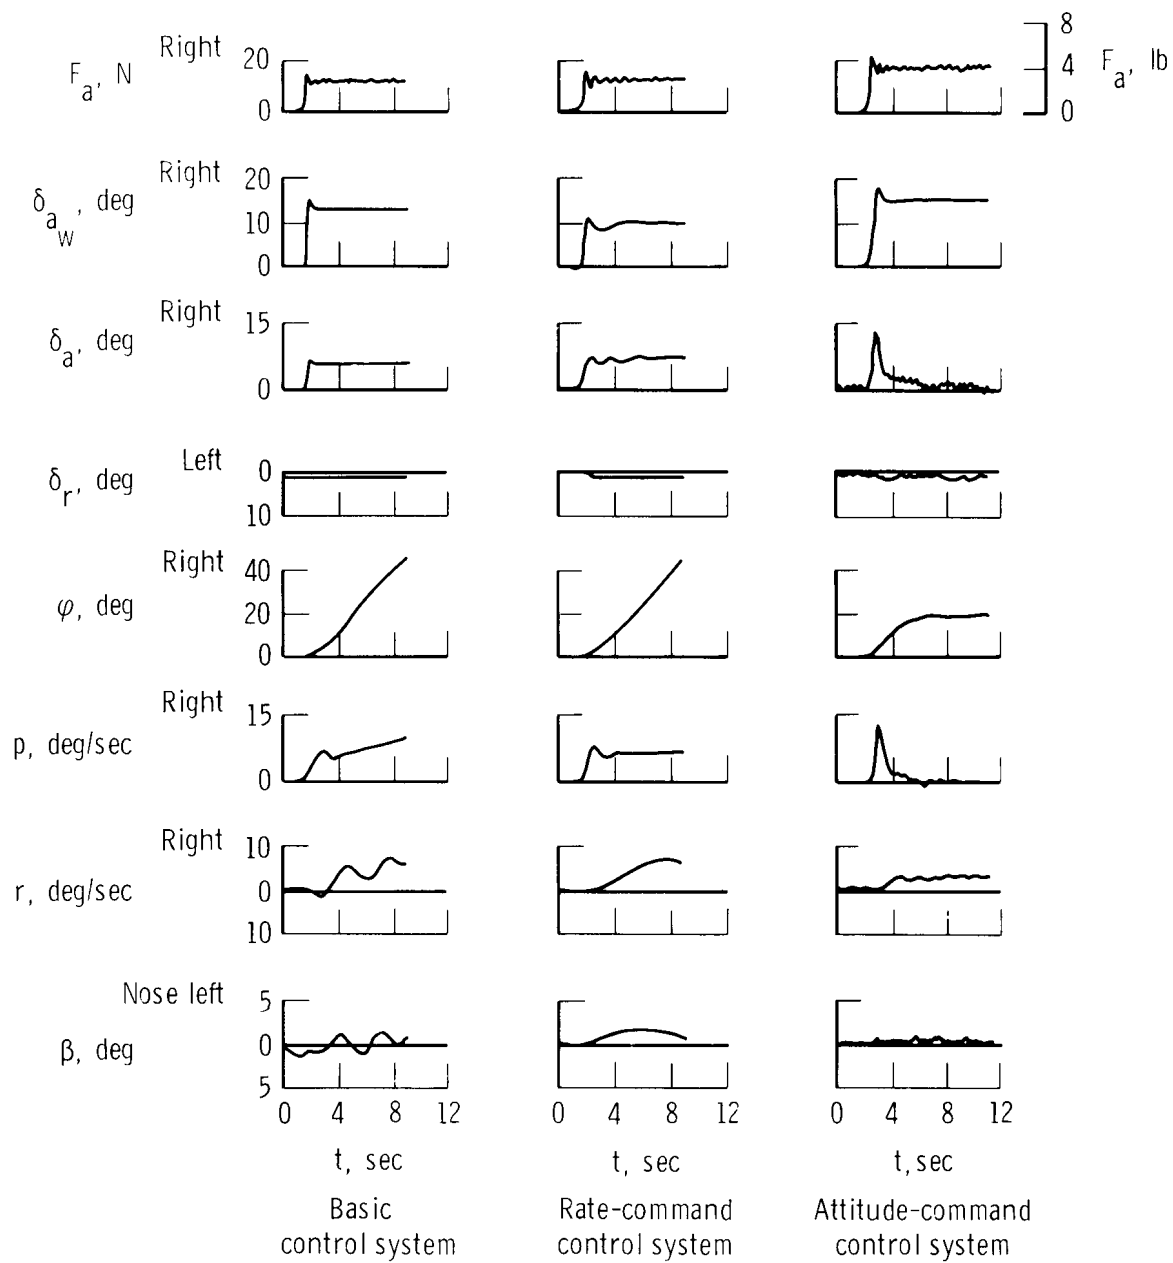
(b) Lateral-directional response.

Figure 11. Concluded.

Lateral-directional response: A comparison of the effects of the basic control system, the rate-command control system, and the attitude-command control system on the lateral-directional response of the airplane is shown in figure 11(b). Time histories of bank angle, roll rate, yaw rate, and sideslip angle after an aileron step command are shown.

With the basic control system, the step input produced a reasonably constant roll rate and varying bank-angle, yaw-rate, and sideslip responses. The light damping of the Dutch-roll oscillations and the adverse yaw are apparent in the yaw-rate and sideslip responses. The negative spiral stability of the airplane is illustrated by the slight divergence in the roll rate.

With the rate-command control system, the step input resulted in a constant roll-rate and varying roll-angle, yaw-rate, and sideslip responses. The system provided effective yaw damping and essentially eliminated the adverse aileron yaw, as shown by the yaw-rate and sideslip responses.

With the attitude-command control system, a step input produced a constant bank angle and varying roll-rate, yaw-rate, and sideslip responses. The airplane remained at the commanded roll attitude until the stick input was removed. The yaw damper attenuated the Dutch-roll oscillations associated with yaw rate, and the interconnect eliminated adverse yaw and minimized the sideslip response as the aircraft rolled into the turn.

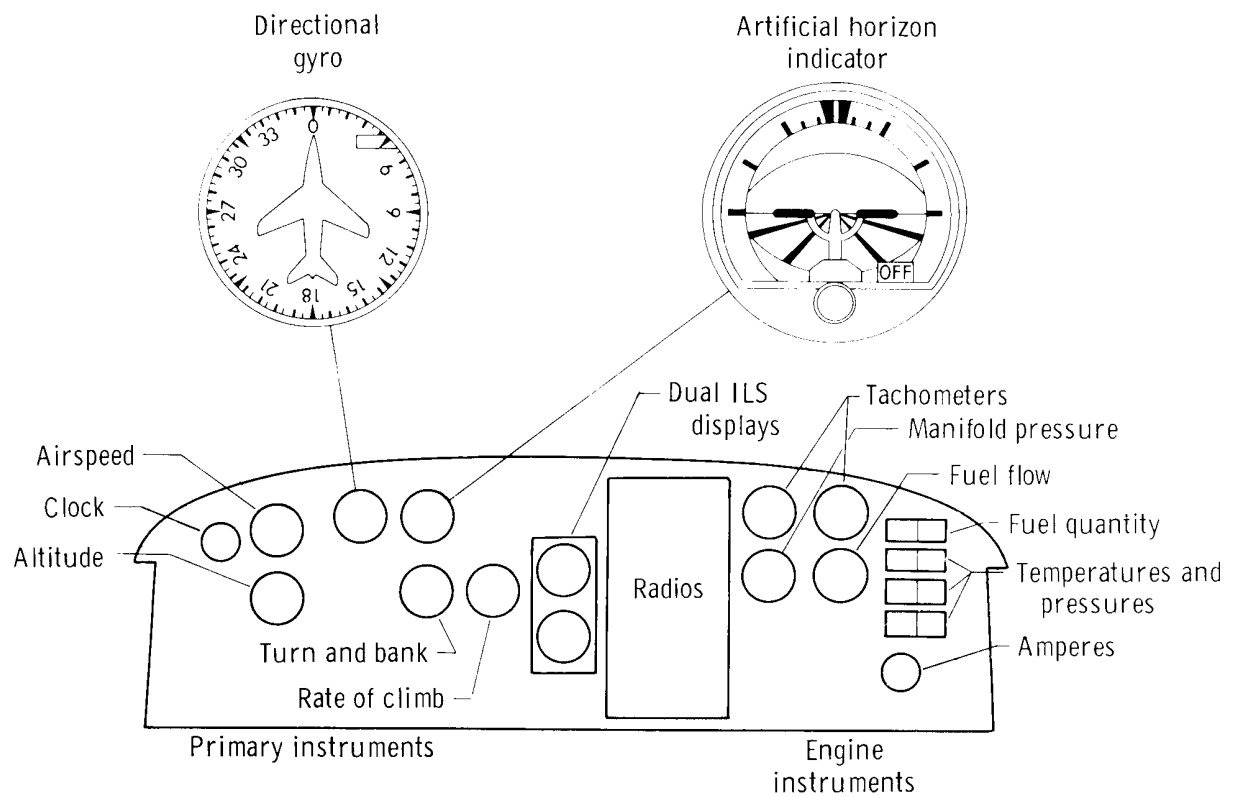
Figure 12. Basic instrument display .

Basic display.— Figure 12 shows the basic instrument display, which was used during the first phase of the program. ILS approaches were flown with the basic display and the basic control system, rate-command control system, and attitude-command control system. As the directional gyro and artificial horizon indicators

show, the instruments were typical of general aviation aircraft. The basic guidance display operated from a conventional radio receiver, and glide-slope and localizer error information were presented on a conventional cross-pointer indicator.

The pilots commented that to monitor the basic instrument display (fig. 12) they had to scan half the instrument panel. Furthermore, the engine performance instruments were on the other side of the cockpit. The head movement necessary to monitor them caused a significant time loss because the pilot's eyes had to refocus. Monitoring the ILS instruments in conjunction with the directional gyro was particularly difficult. In addition, the attitude indicator was difficult to interpret rapidly because of its lack of sensitivity, small size, and cluttered appearance. These deficiencies made the instruments impossible to monitor with peripheral vision.

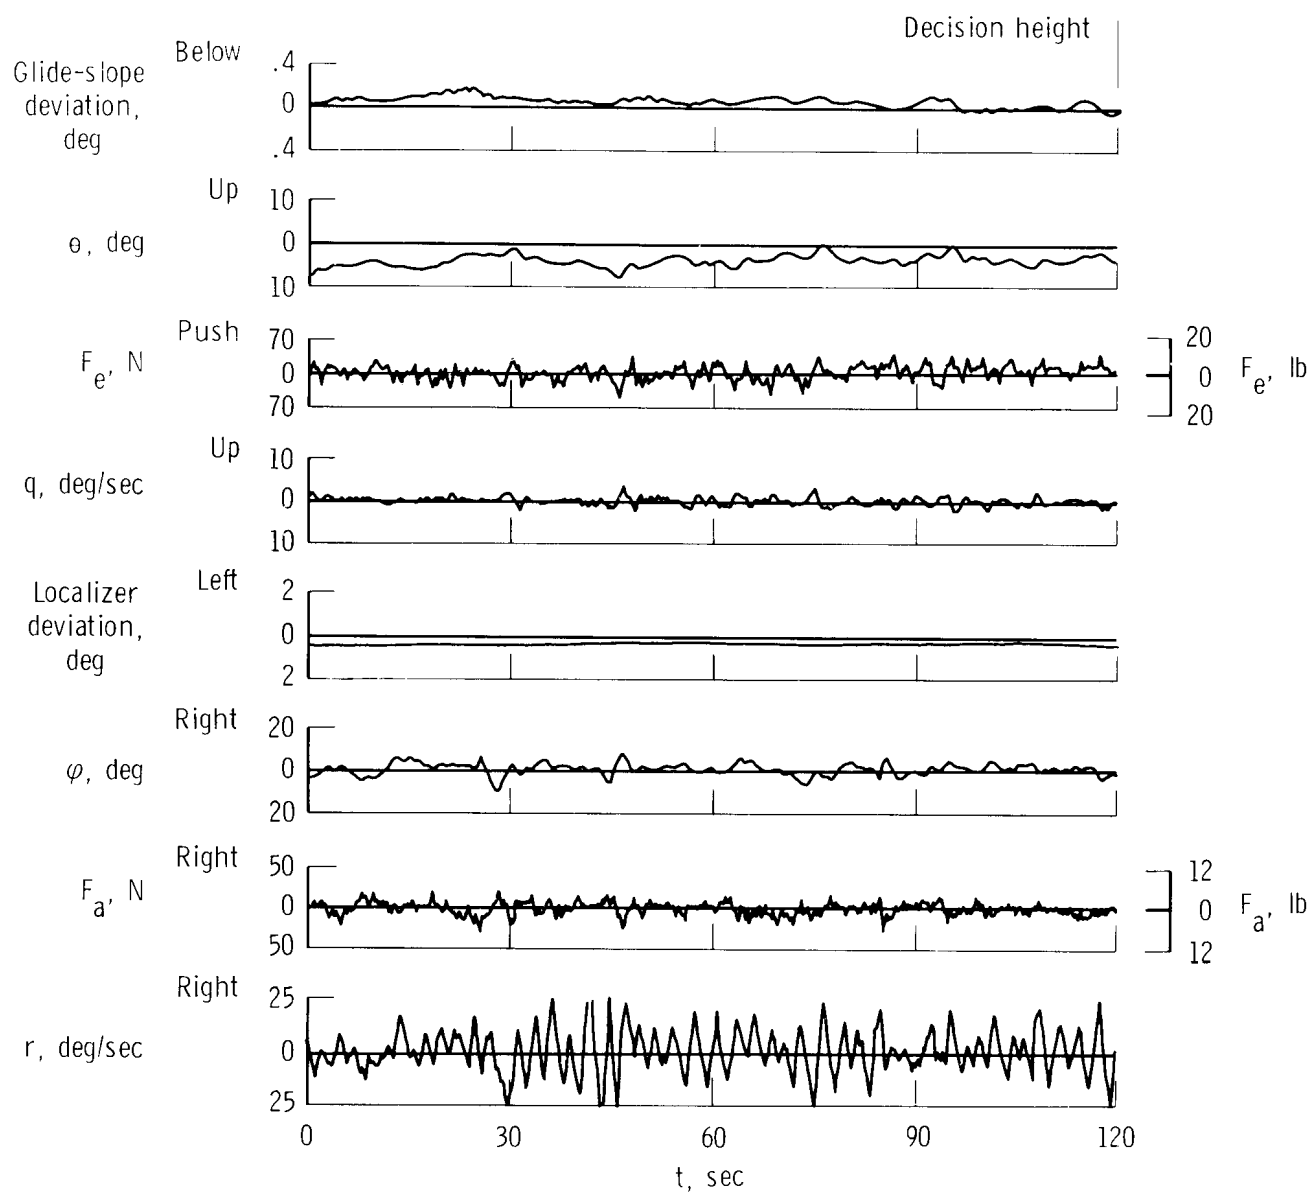
Figure 21. ILS approach in turbulence with basic control system and flight-director display. $V_i = 100$ knots; $\delta_f = 27^\circ$; gear down; measured turbulence = 0.40 m/sec (1.32 ft/sec) rms.
